VILLAGE: CHUDENAPURA, HOBLI: KENGERI, TALUK: BANGALORE SOUTH.
SURVEY NO: 15 LAKE

{Lake Sketch Prepared As per the Order of Honorable High Court Vide No: WP NO:38401 / 2014 PIL Dated:02/06/2021}

VILLAGE: HEMMIGEPURA, HOBLI: KENGERI, TALUK: BANGALORE SOUTH.
SURVEY NO: 61 LAKE

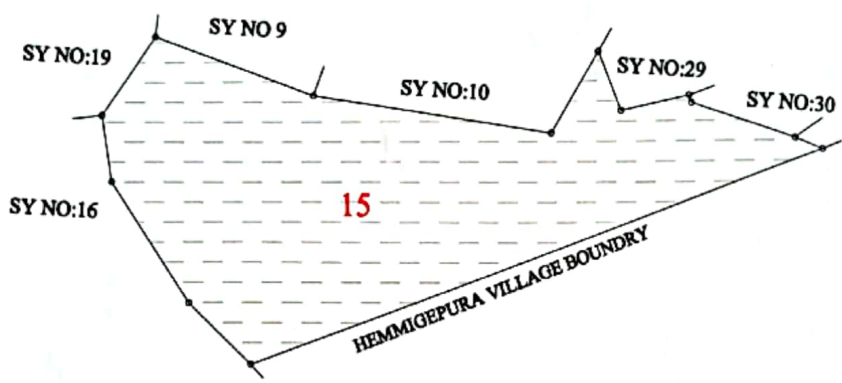
Scale: 1cm=1584cm

1. Sketch Prepared As per the direction of DDLR Letter No: ಜತಾಂಸ/ಭೂಲನ/ತಾಂ(6)ಎವ/21/2021 ದಿನಾಂಕ:28/06/2021 and memo of ADLR Bangalore South No: ಭೂಸನ/ಓ.ಆರ್/ಇತರ:273/2020-21 ದಿನಾಂಕ:02/05/2024
2. Survey Department(Land Records) is only responsible for measurement and extent of the lake.
3. The measurement carried out as per Survey Records in presence of BBMP Engeenier
4. As fencing of the Lake boundary is alreadydone by the BBMP as per previous survey sketch during present field inspection that fence (Chain and Link Fencing) is still in extent only leftout area of the Lake is now demarketed as as enchroachment as per Survey document.
5. Lake Details as below (The Details of the Encroachment in lake are need to be verify from conserved authority)

SL No	LAKE SY NO	EXTENT OF THE LAKE		DETAILS OF THE ENCHROCHMENT IN LAKE						Total Area of Enchroachment (A-G)	VACANT LAND (A-G)	TOTAL ARRA	REMARKS
		AS PER AKHARABAND (A-G)	AS PER MEASUREMENT (A-G)	PRAVITE ENCHROCHMENT			GOVT ENCHROCHMENT						
				Block No	TYPE OF ENCHROCHMENT	EXTENT (A-G)	Block No	TYPE OF ENCHROCHMENT	EXTENT (A-G)				
1	15	20-39	20-39	—	—	—	—	—	—	—	—	20-39

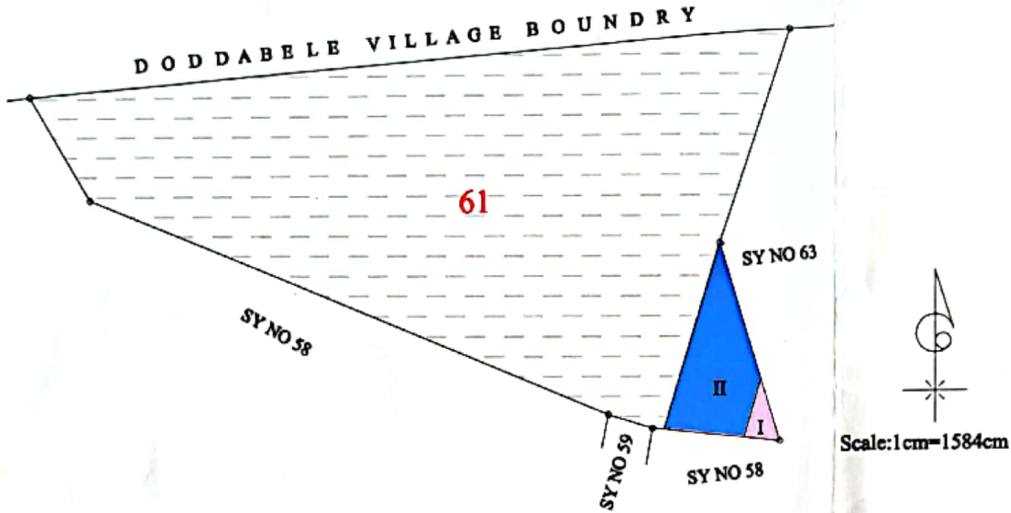
1. Sketch Prepared As per the direction of DDLR Letter No: ಜತಾಂಸ/ಭೂಲಾನಿ/ತಾಂ(6)ಎವ/21/2021 ದಿನಾಂಕ:28/06/2021 and memo of ADLR Bangalore South No: ಭೂಸವ/ಕ.ಆರ್/ಇತರ:273/2020-21 ದಿನಾಂಕ:02/05/2024
2. Color Shows the Road encroachment details.
3. Color Shows the priwet encroachment details.
4. Survey Department(Land Records) is only responsible for measurement and extent of the lake.
5. The measurement carried out as per Survey Records in presence of BBMP Engeenier
6. As fencing of the Lake boundary is alreadydone by the BBMP as per previous survey sketch during present field inspection that fence (Chain and Link Fencing) is still in extent only leftout area of the Lake is now demarketed as as encroachment as per Survey document.

7. Lake Details as below (The Details of the Encroachment in lake are need to be verify from conserved authority)

SL No	LAKE SY NO	EXTENT OF THE LAKE		DETAILS OF THE ENCROACHMENT IN LAKE						Total Area of Encroachment (A-G)	VACANT LAND (A-G)	TOTAL AREA	REMARKS
		AS PER AKHARABAND (A-G)	AS PER MEASUREMENT (A-G)	Block No	TYPE OF ENCROACHMENT	EXTENT (A-G)	Block No	TYPE OF ENCROACHMENT	EXTENT (A-G)				
1	61	16-15	16-15	I	MUSLIM BARRAKA	0-05	II	ROAD	1-00	1-00	15-15	16-15
